Oyster Harbor Services Inc. Osterville, Massachusetts

Hazard Tree Inventory

This report conducted by Bartlett Tree Experts for Oyster Harbors Services (client) represents the visual inspection of all trees located within 10 feet of the paved road edge encompassing all paved roadways throughout the Oyster Harbors Island. The inspection took place over a 2-day period from June 27th, 2007 through June 28th, 2007.

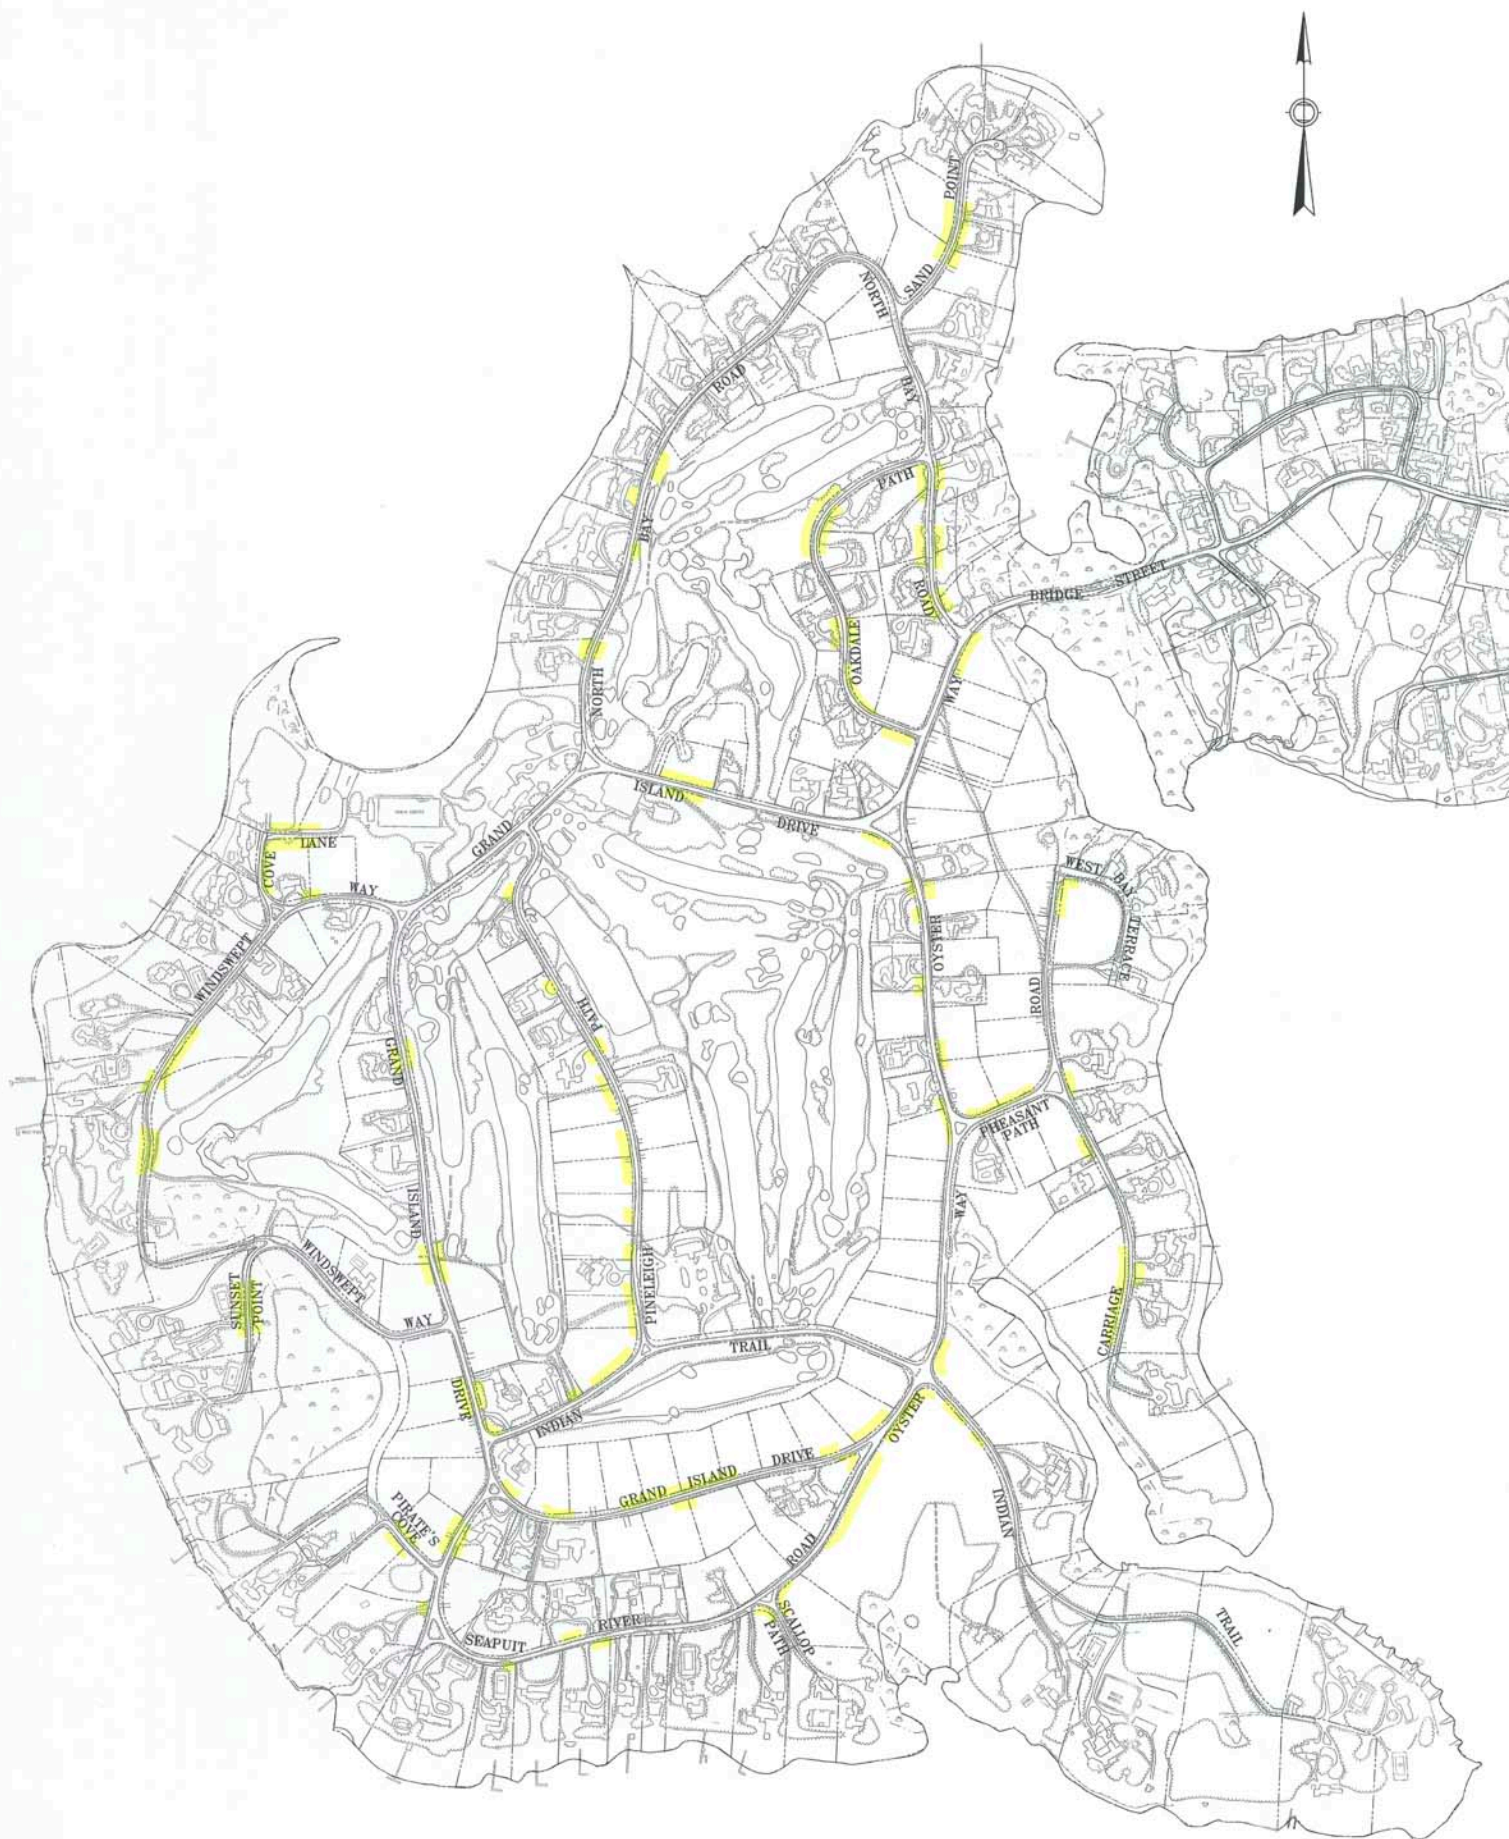
VEGETATION CLEARANCE NEEDS

The following is a highlighted map detailing areas of paved roadways in need of vegetation clearance. The clearance work suggested is to maintain standard roadway clearance of 3 feet from paved edges and 14 feet high over paved surfaces.

Please refer to the attached island road map highlighting the areas in need of this type of clearance.
