Oyster Harbor Services Inc. Osterville, Massachusetts

Hazard Tree Inventory

This report conducted by Bartlett Tree Experts for Oyster Harbors Services (client) represents the visual inspection of all trees located within 10 feet of the paved road edge encompassing all paved roadways throughout the Oyster Harbors Island. The inspection took place over a 2-day period from June 27th, 2007 through June 28th, 2007.

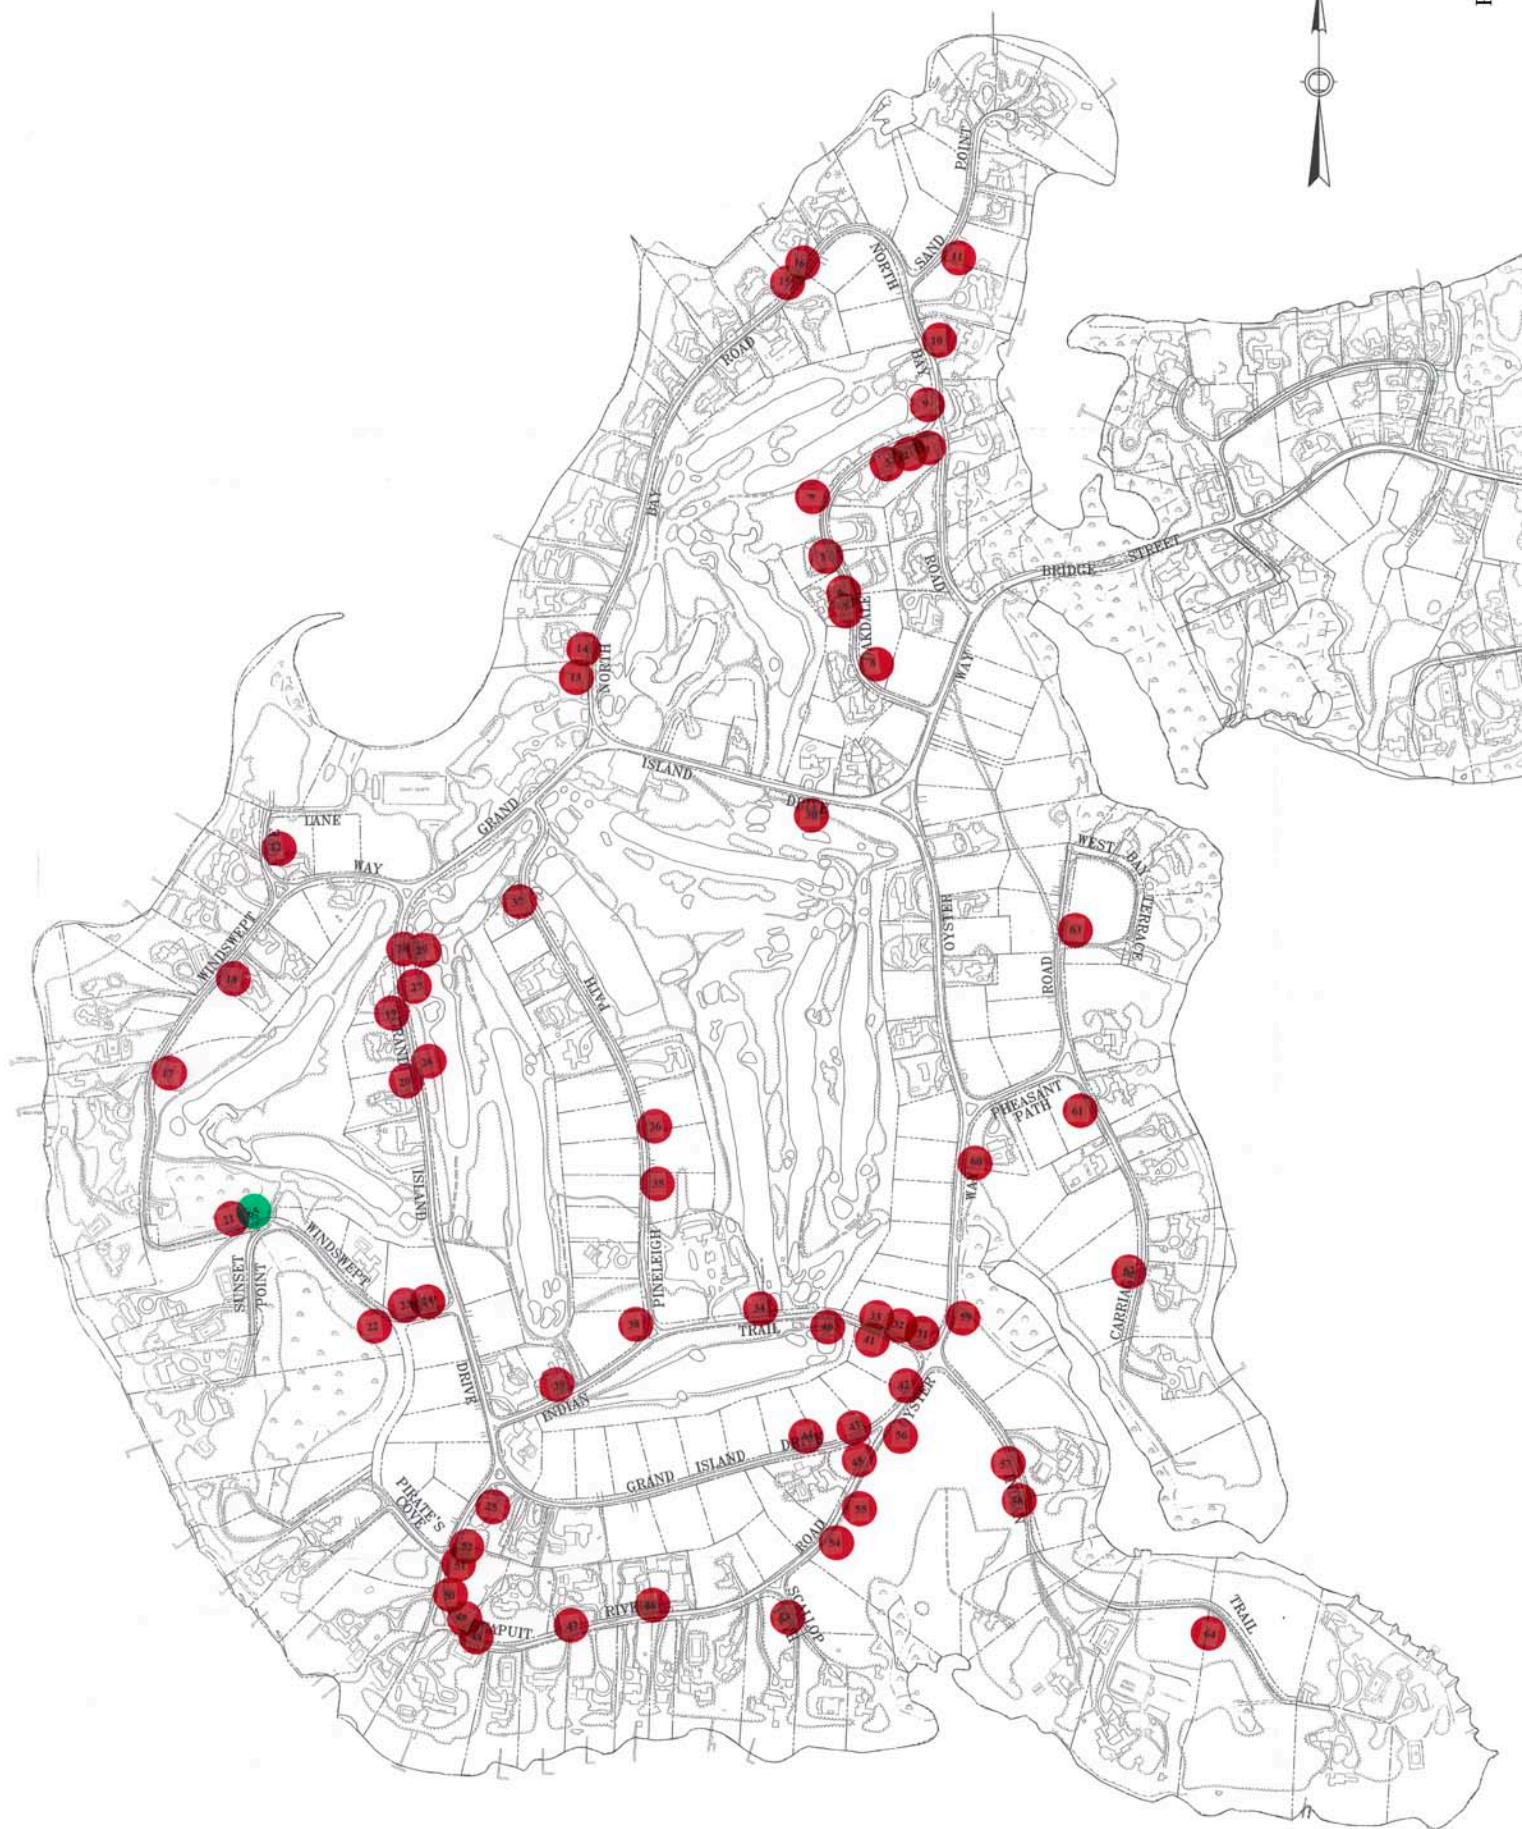
VEGETATION CLEARANCE NEEDS

The following is a highlighted map detailing areas of paved roadways in need of vegetation clearance. The clearance work suggested is to maintain standard roadway clearance of 3 feet from paved edges and 14 feet high over paved surfaces.
